PARATRANSIT VEHICLE TEST AND EVALUATION

Volume I: Ride Comfort and Quality Tests

1. Report No. UMTA-MA-06-0041-77-10	2. Government Accession No.	3. Recipient's Catalog No.	
4. Title and Subtitle LORAN AUTOMATIC VEHICLE MONITORING SYSTEM, PHASE I Volume I: Test Results		5. Report Date August 1977

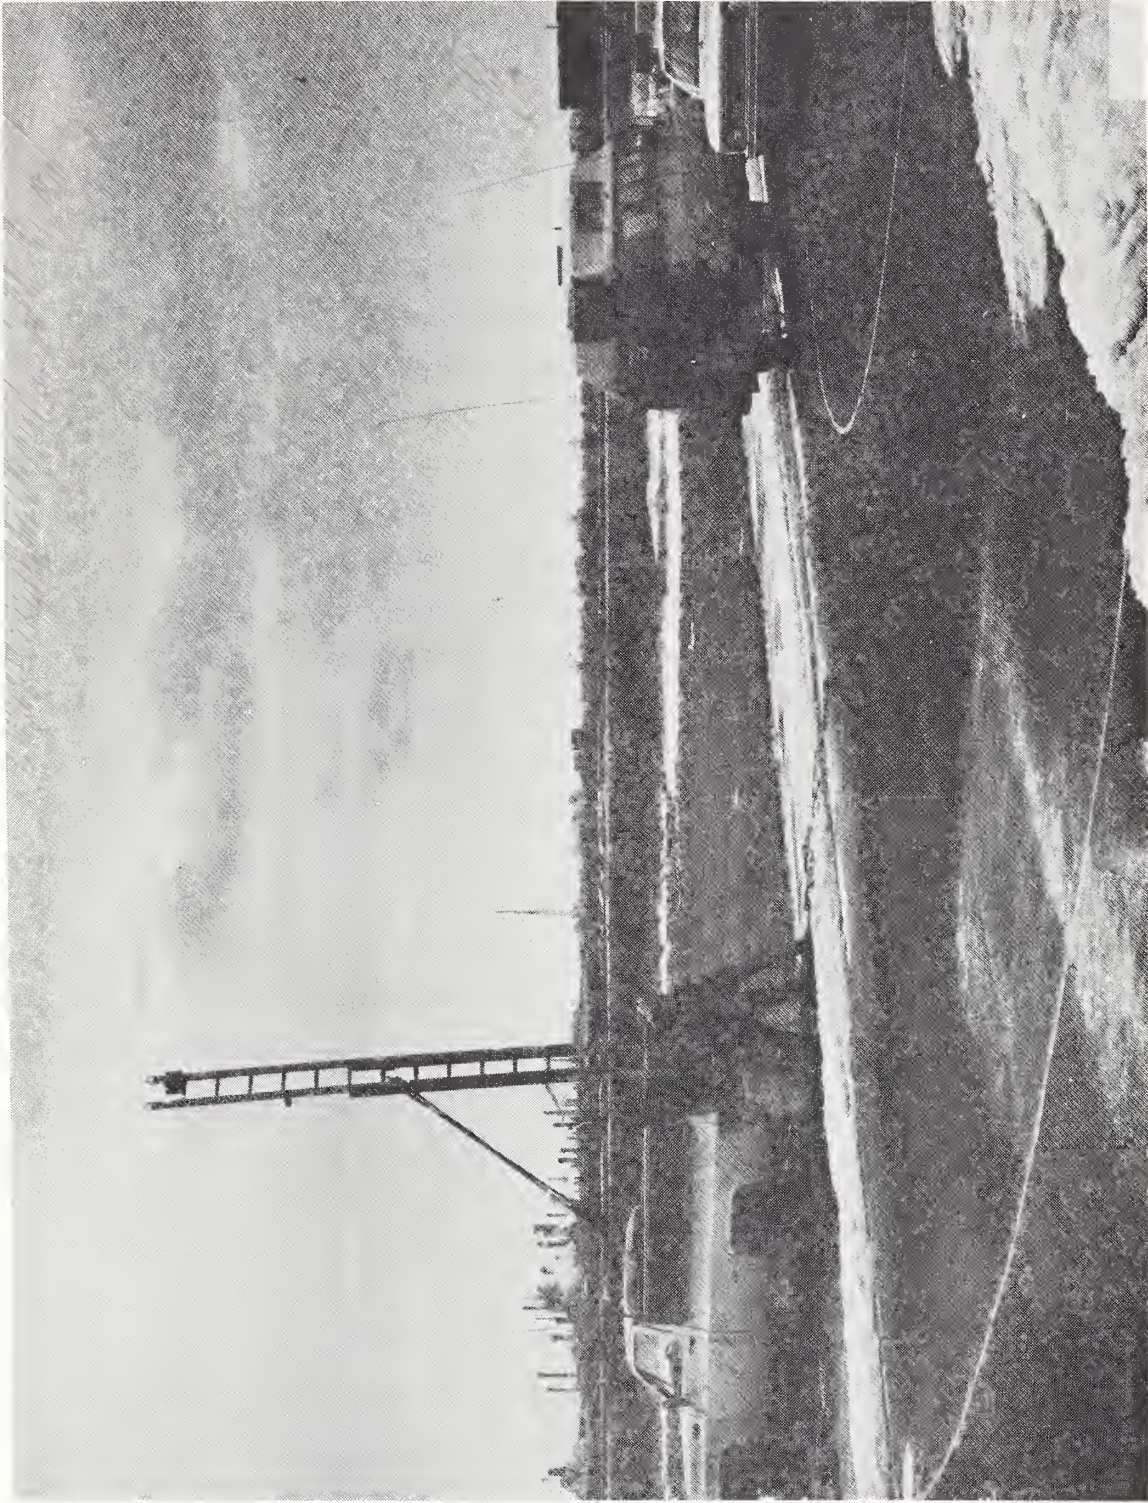
Figure 4-2. Test Vehicle and Mobile Supporting Structure (Augmentor Shown At Top of Ladder)

In order to perform these tests, a mobile test vehicle and portable supporting augmentor structures were utilized as shown in Figure 4-2. These were positioned and maneuvered at the Philadelphia Naval Base Airfield. Due to snow and ice (as can be seen in Figure 4-3), a long but very narrow pathway which was plowed by Navy personnel was utilized on the runway. The measurements recorded were:

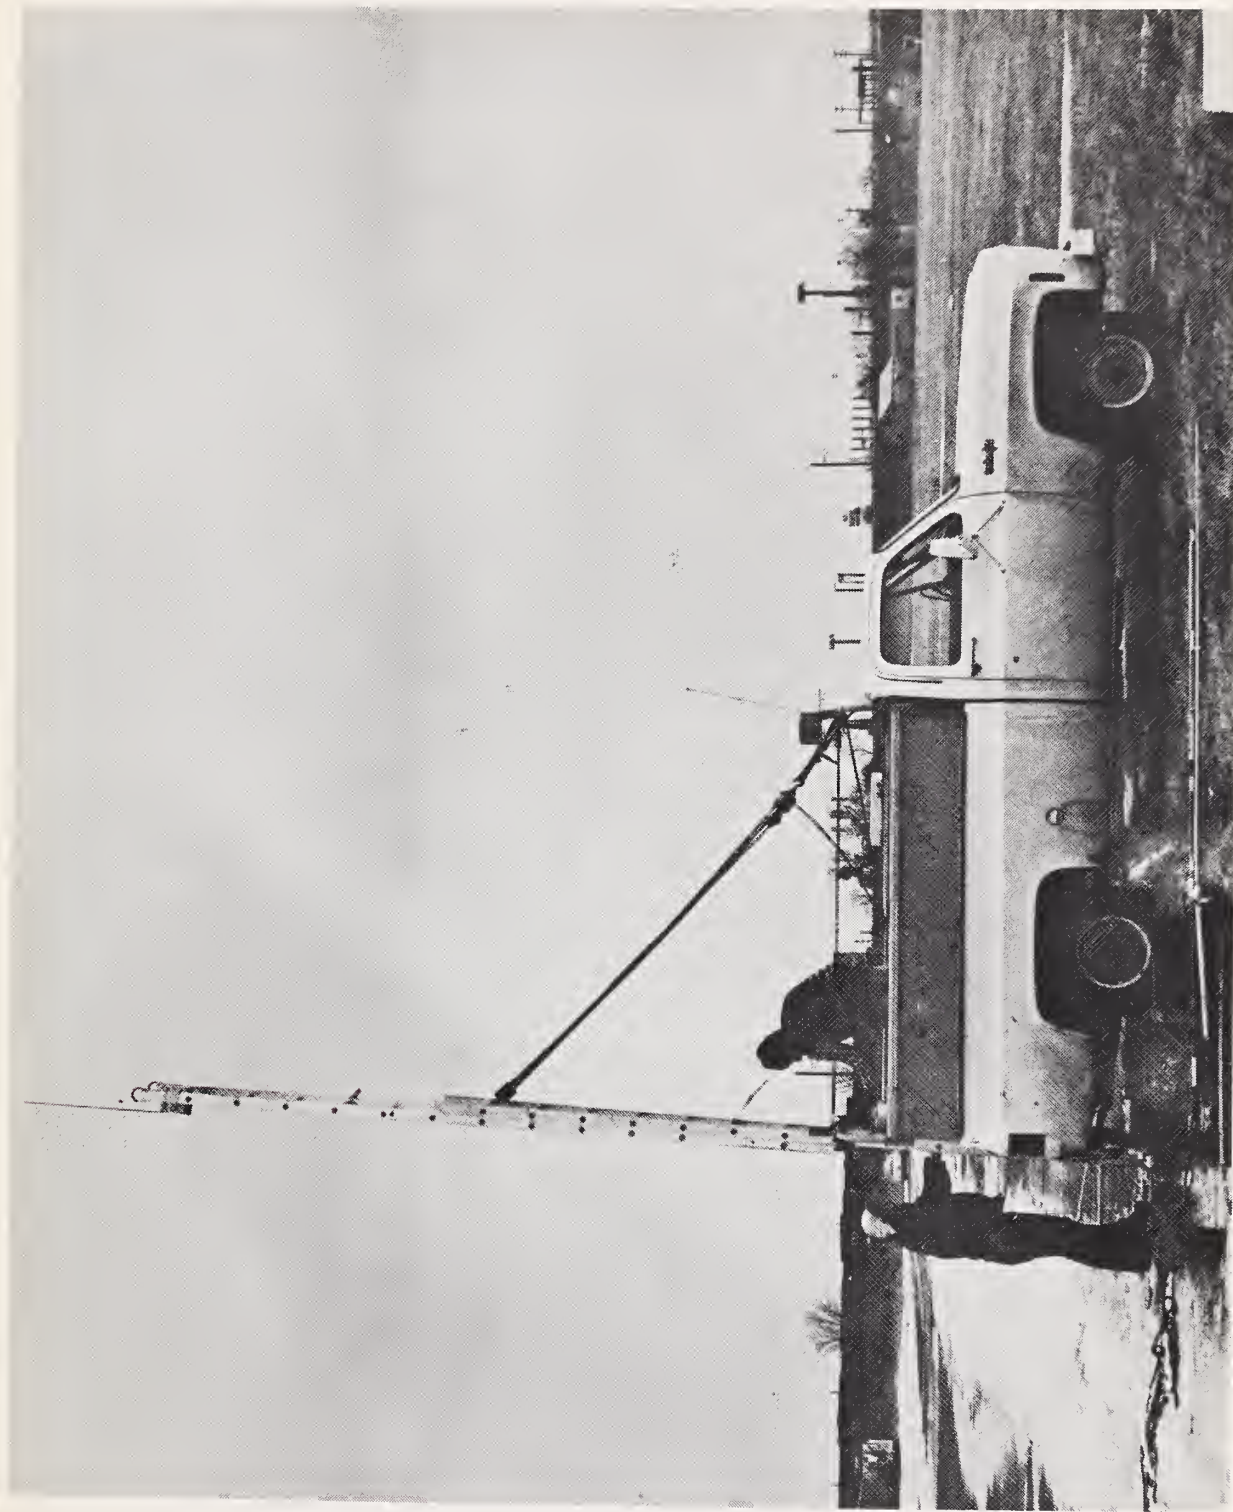
Figure 4-3. Runway Path (Shown to left of vehicle) and Mobile Supporting Structure

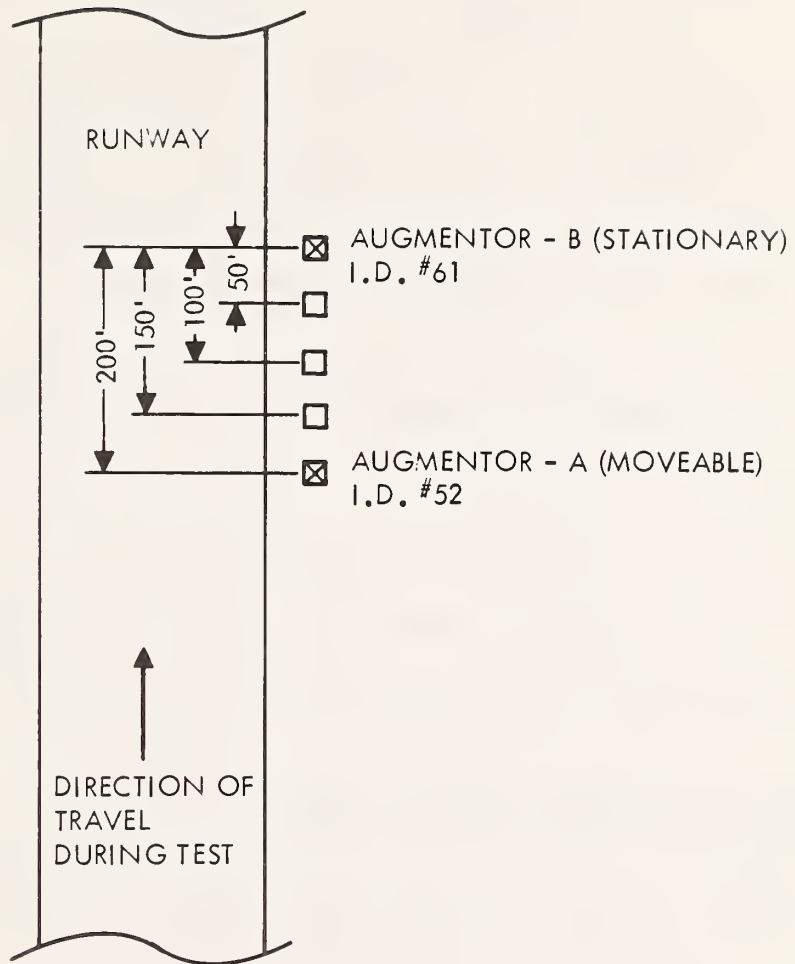
Figure 4-4. Augmentor Interference Test

The augmentors were positioned as shown in Figure 4-4.

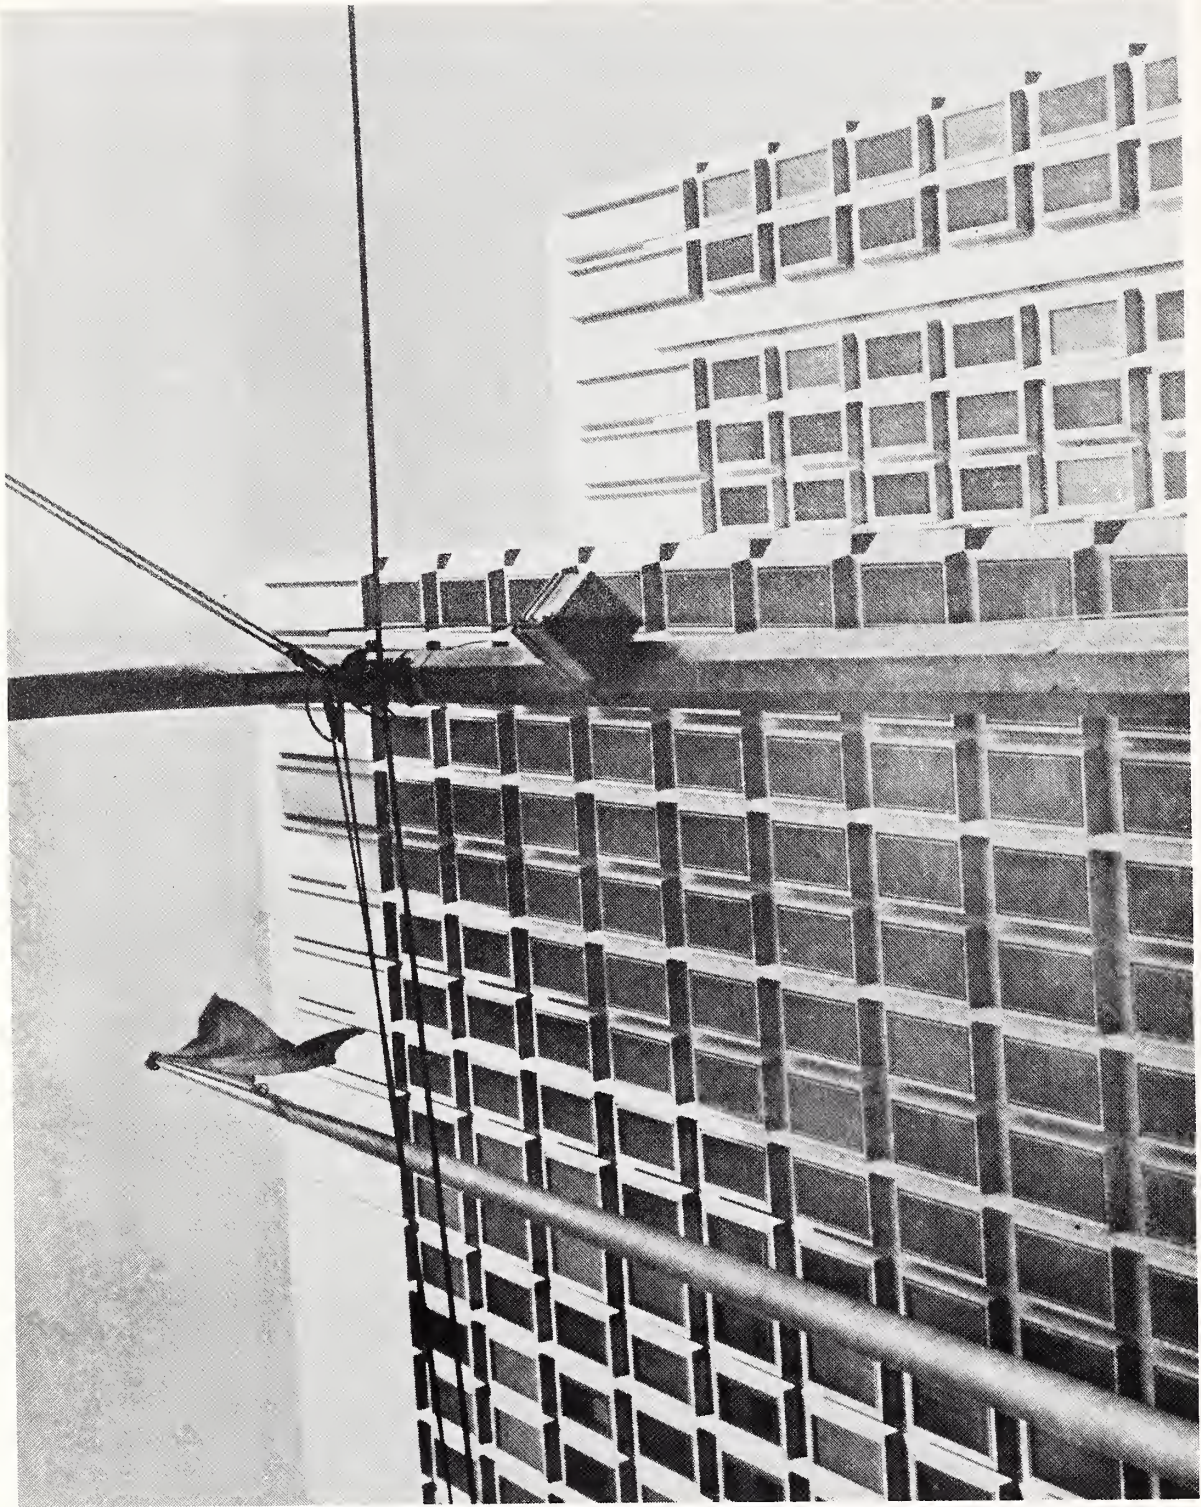
Figure 4-5B. Test Augmentor for Traffic Special Case Test
(Augmentor Shown At 28 Feet Elevation)

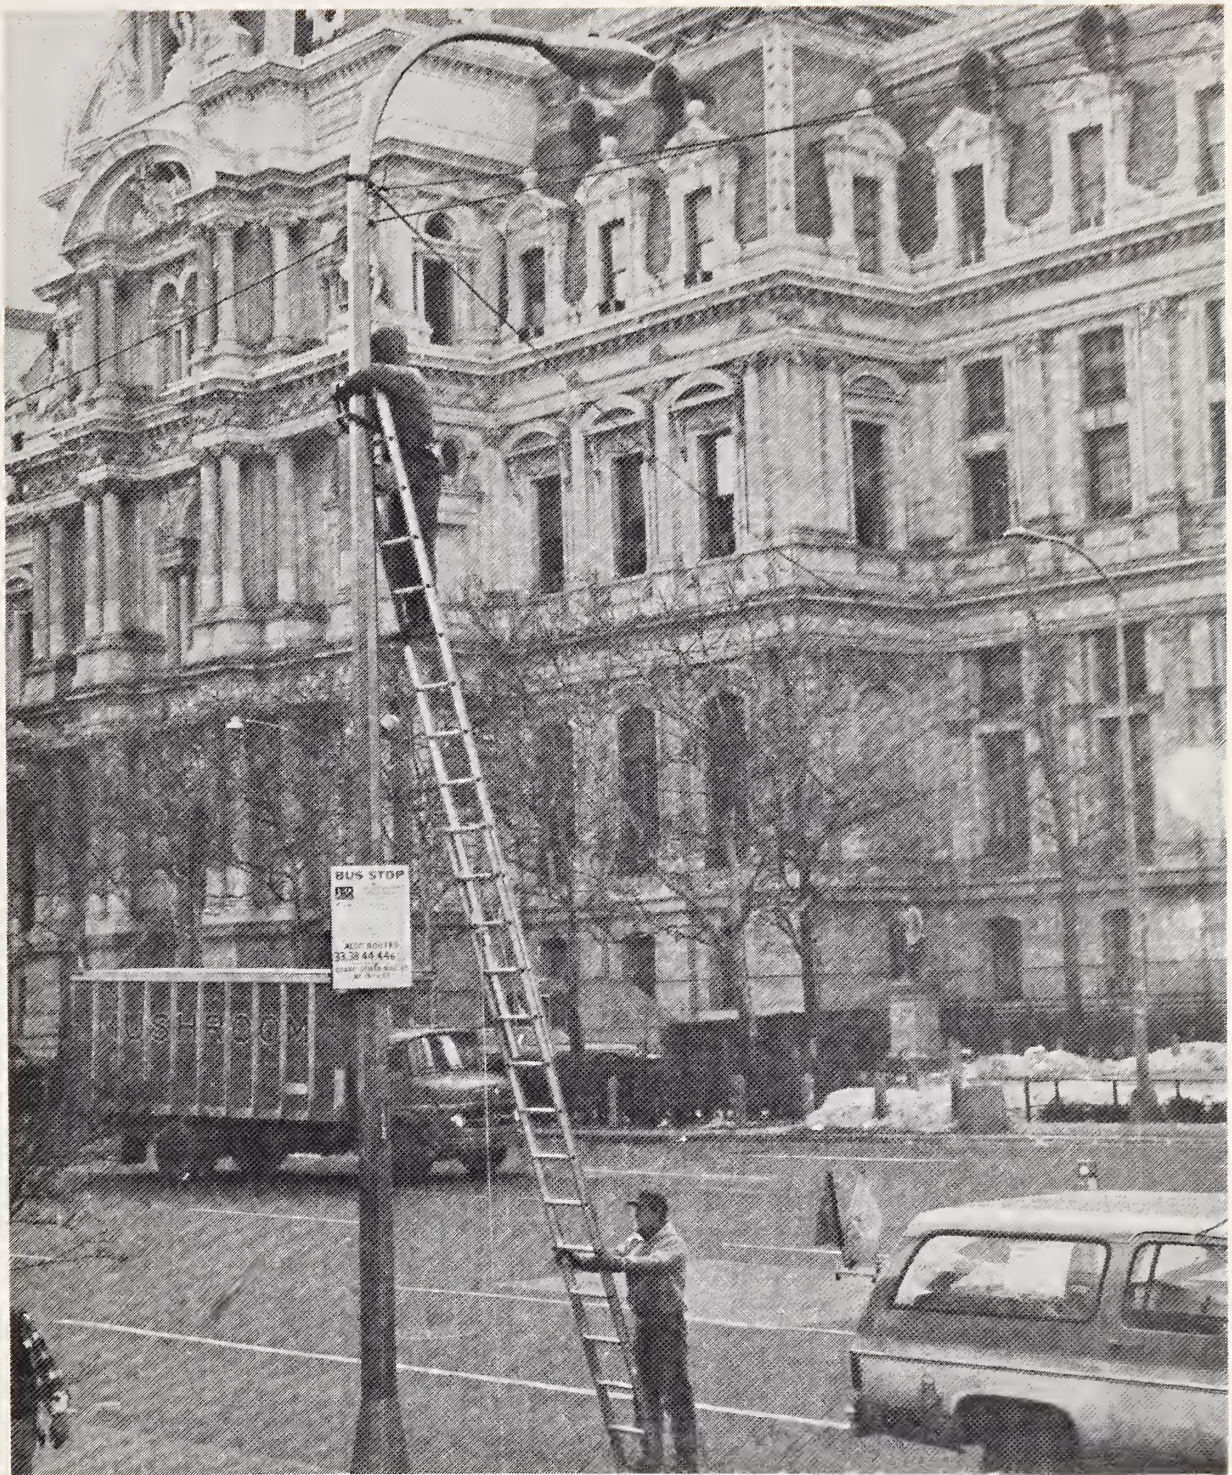
Figure 4-6. Test Augmentor for Traffic Special Case Test
(Elevation of Test Augmentor was adjusted for each special case run)

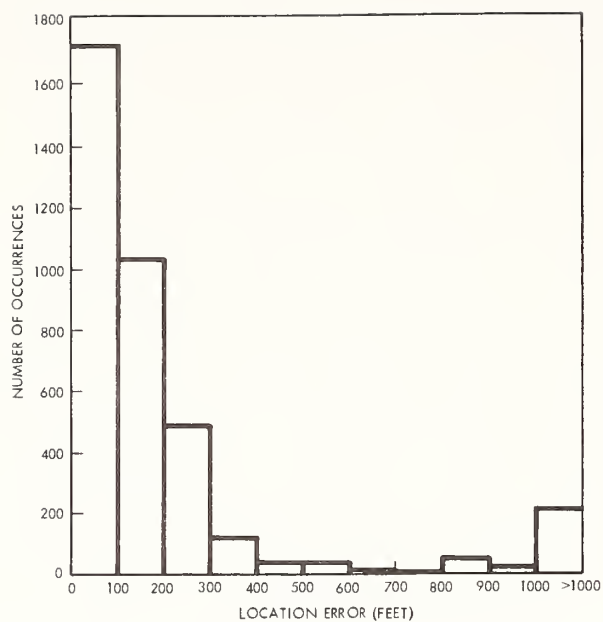
Figure 6-5A. Location Accuracy Histogram (System Simulation)
(Fixed Route Tests #10012 - 10047)

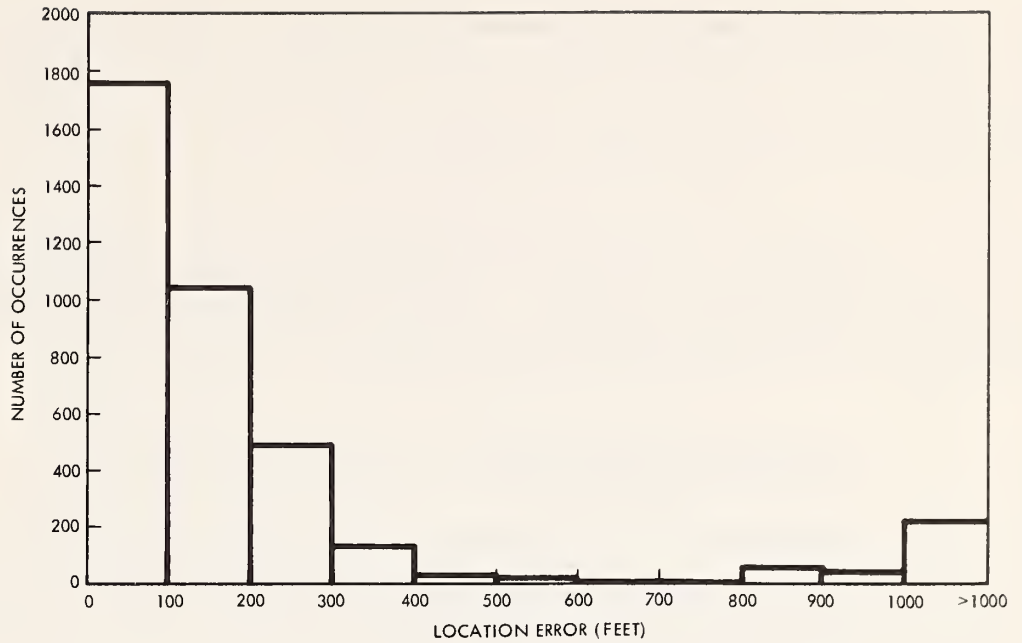
Figure 6-7A. Location Accuracy Histogram
(System Simulation With 5% Missing Data)
(Fixed Route Tests #10012 - 10047)

6.2.2.3 System Simulation with 5% Lost Data - The system simulation described in subsection 6.2.2.2 was repeated for all 30 tests with a random 5% of all data deleted. This simulates the practical system operating conditions. Results do not significantly differ from the straight simulation. The error at the 95th percentile was 1,113 feet and 4,909,901 feet at the 99.5th percentile. Error distribution is shown in Figure 6-7.

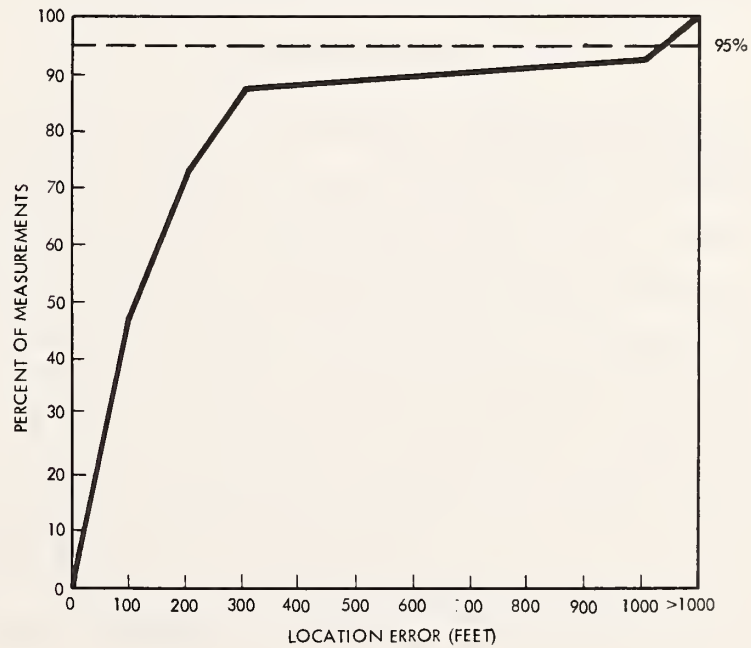
Figure 6-7B. Cumulative Location Error
(System Simulation With 5% Missing Data)
(Fixed Route Tests #10012 - 10047)

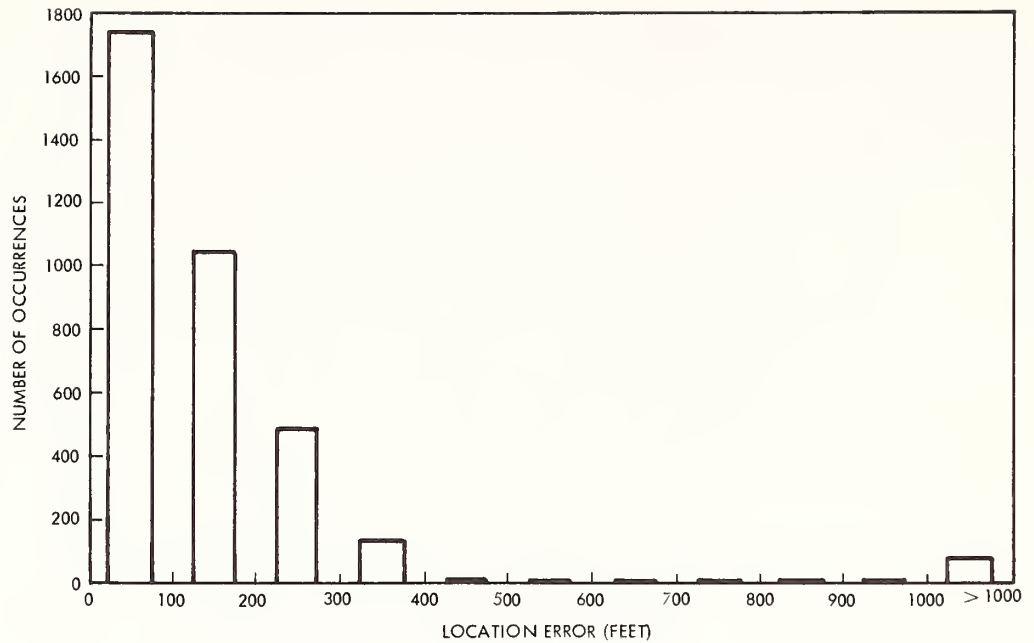
Figure 6-11A. Location Accuracy Histogram
(System Simulation With 5% Missing Data)
(Fixed Route Tests (All) Except #10016 and 10017)

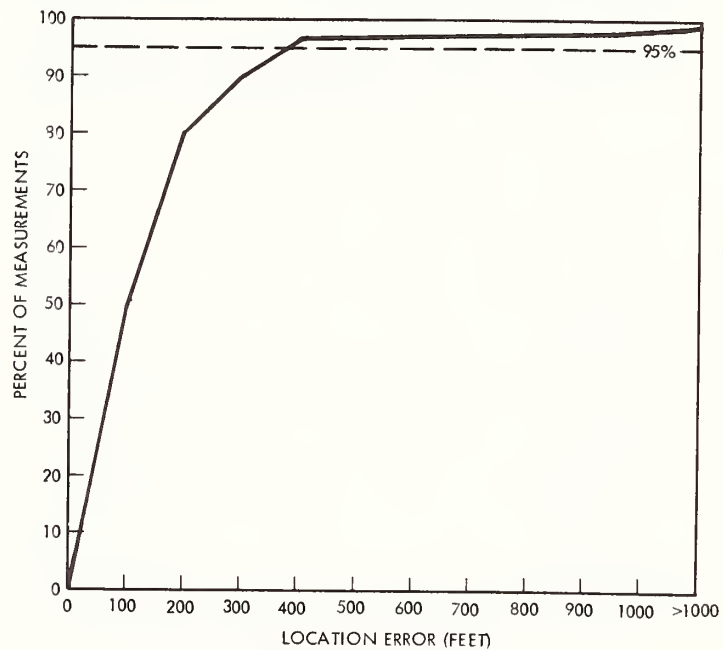
Figure 6-11B. Cumulative Location Error
(System Simulation With 5% Missing Data)
(Fixed Route Tests (All) Except #10016 and 10017)

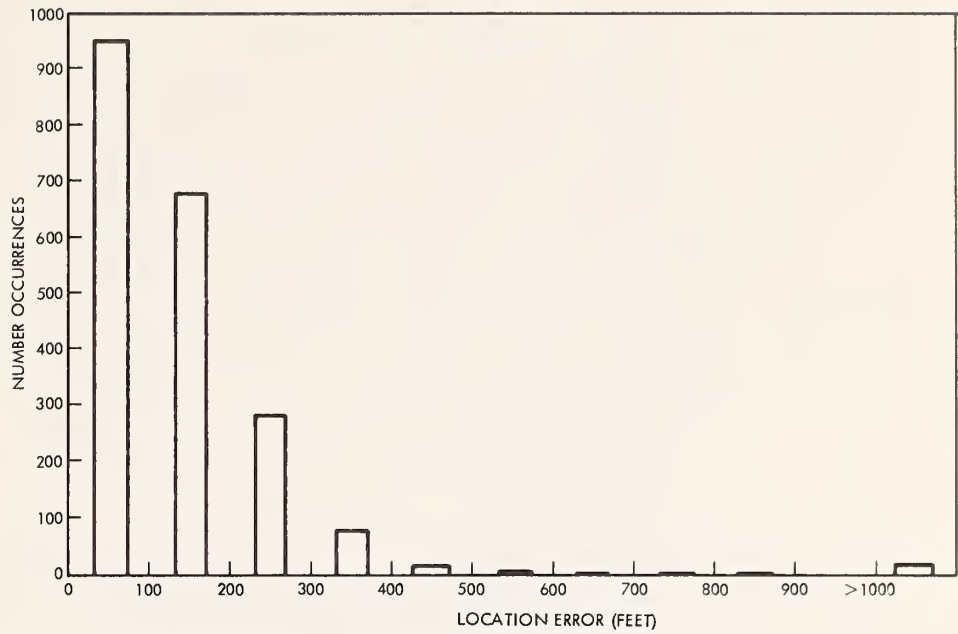
Figure 6-12A. Location Subsystem Error Histogram
(Fixed Route Tests #10026 - 10047)

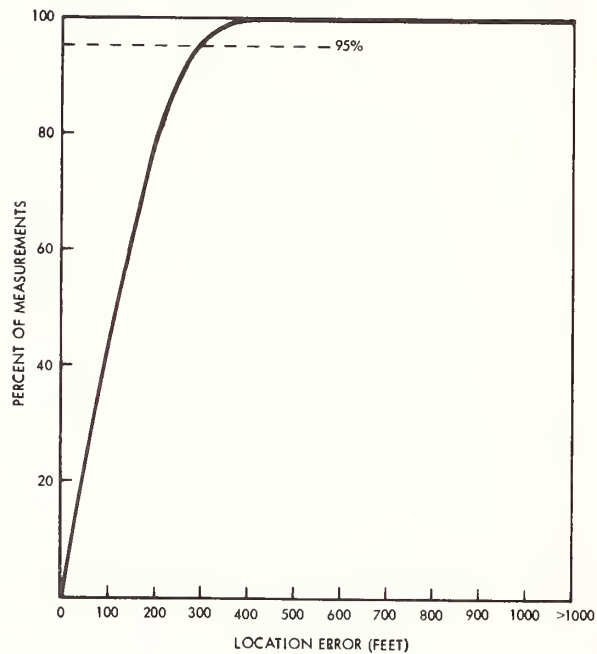
Figure 6-13B. Cumulative Location Error (System Simulation)
(Fixed Route Tests #10026 - 10047)

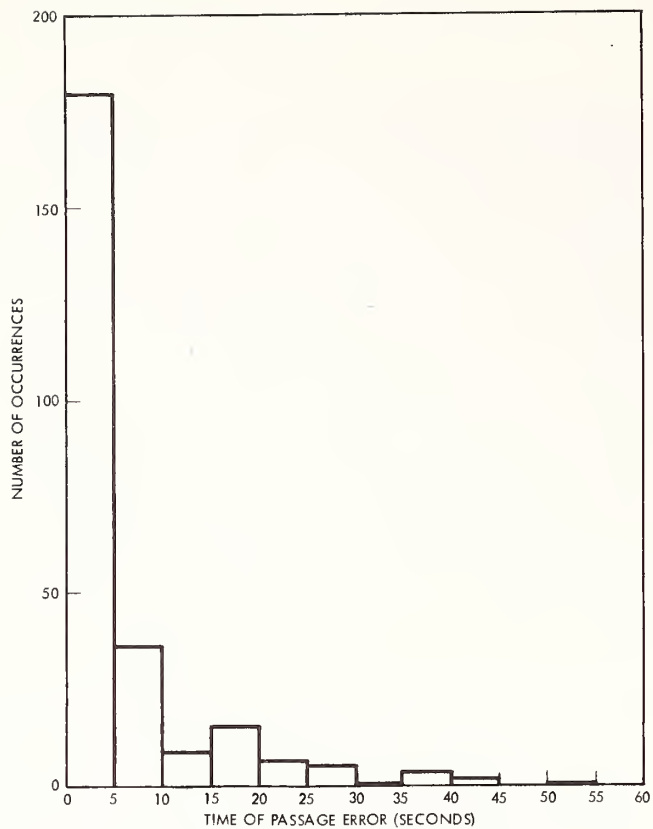
Figure 6-14A. Time of Passage Histogram
(Fixed Route Tests #10026 - 10047)

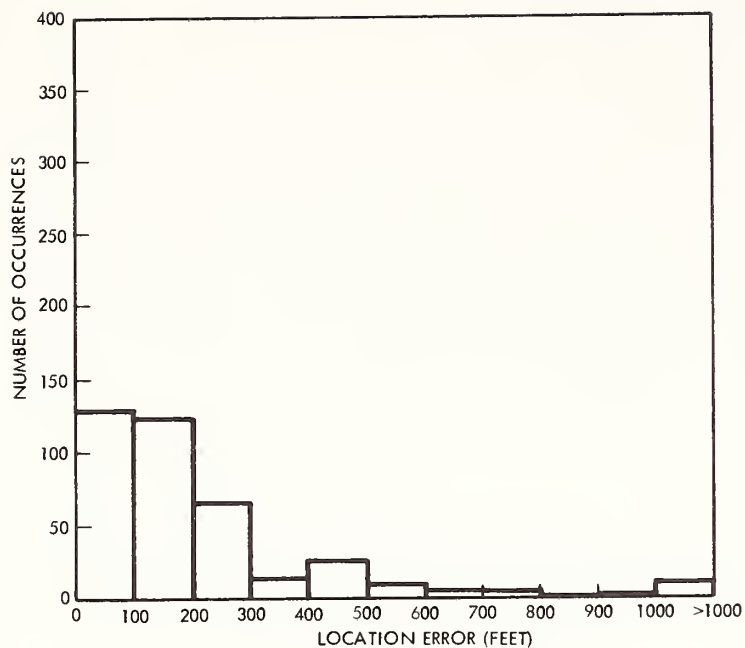
Figure 6-21A. Location Accuracy Histogram
(System Simulation With 5% Missing Data)
(Random Route Tests #20001 - 20005)

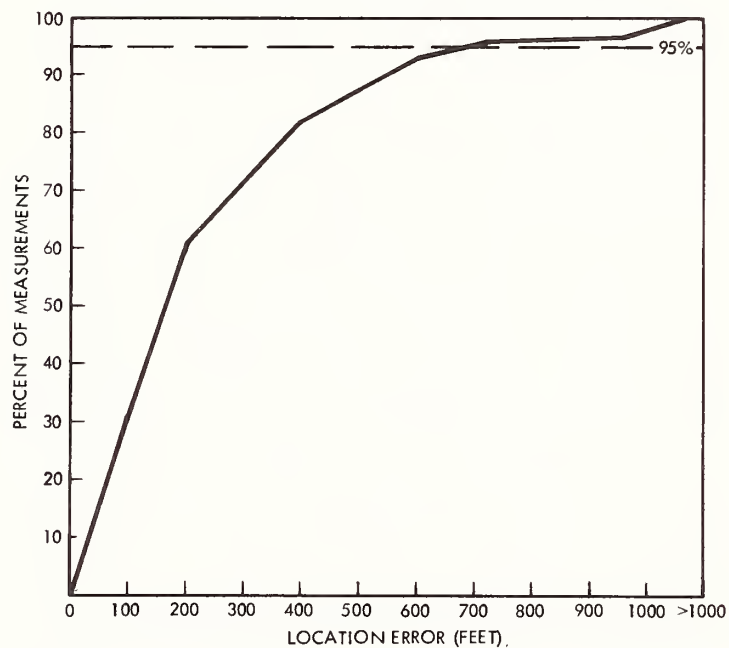
Figure 6-21B. Cumulative Location Error
(System Simulation With 5% Missing Data)
(Random Route Tests #20001 - 20005)

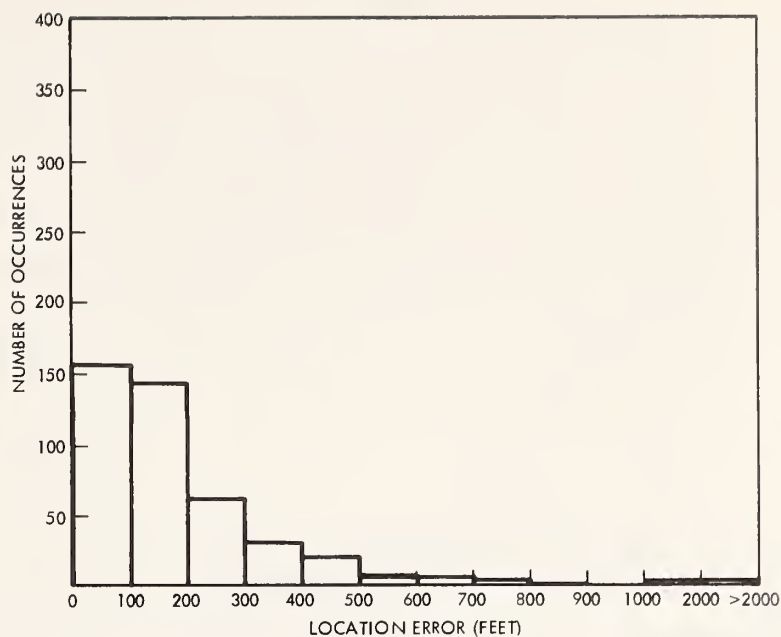
Figure 6-22A. Location Accuracy Histogram
(System Simulation With 5% Missing Data and Improved Software)
(Random Route Tests #20001 - 20005)

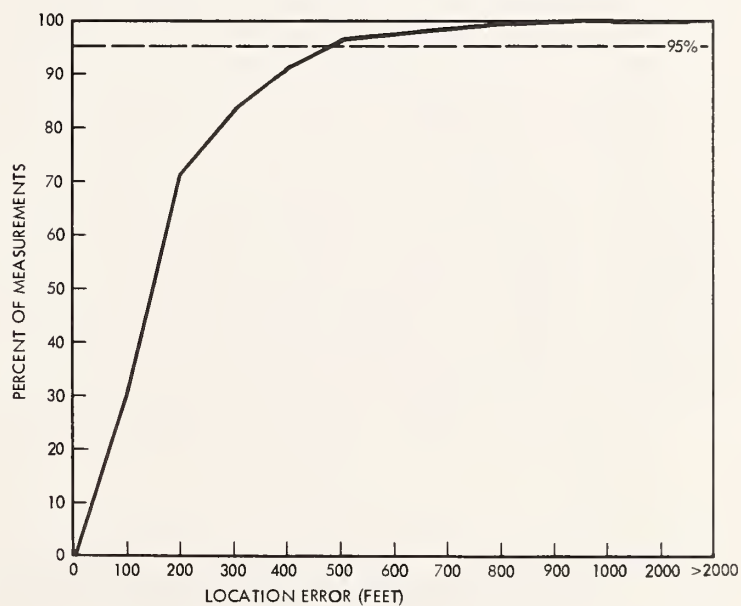
Figure 6-22B. Cumulative Location Error
(System Simulation With 5% Missing Data and Improved Software)
(Random Route Tests #20001 - 20005)

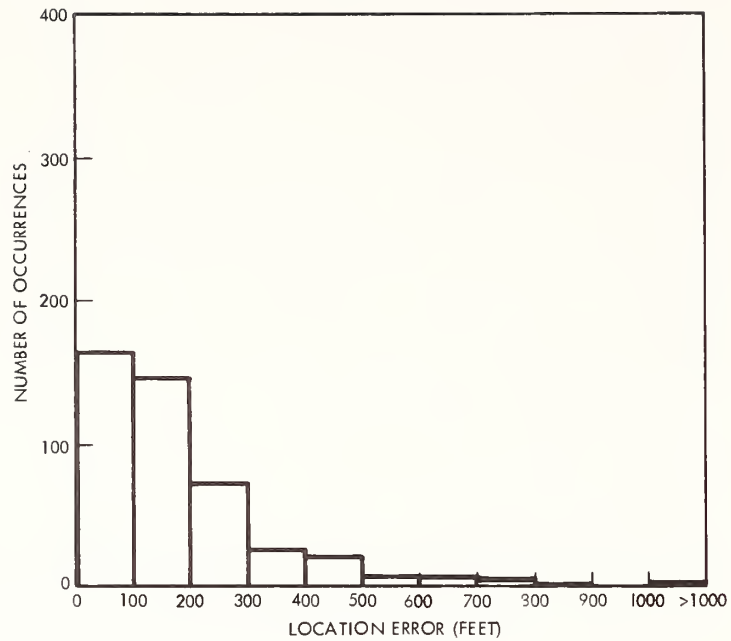
Figure 6-23A. Location Accuracy Histogram
(System Simulation and Improved Software)
(Random Route Tests #20001 - 20005)

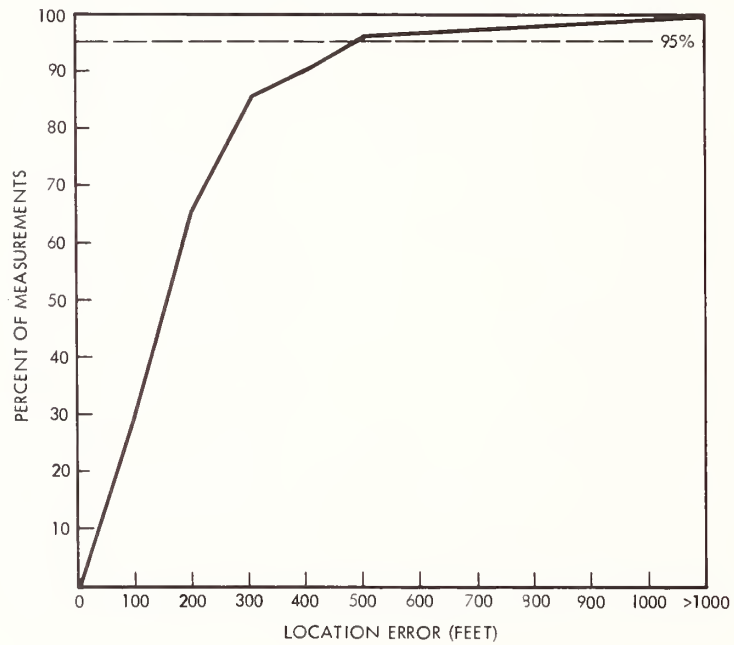
Figure 6-23B. Cumulative Location Error
(System Simulation and Improved Software)
(Random Route Tests #20001 - 20005)

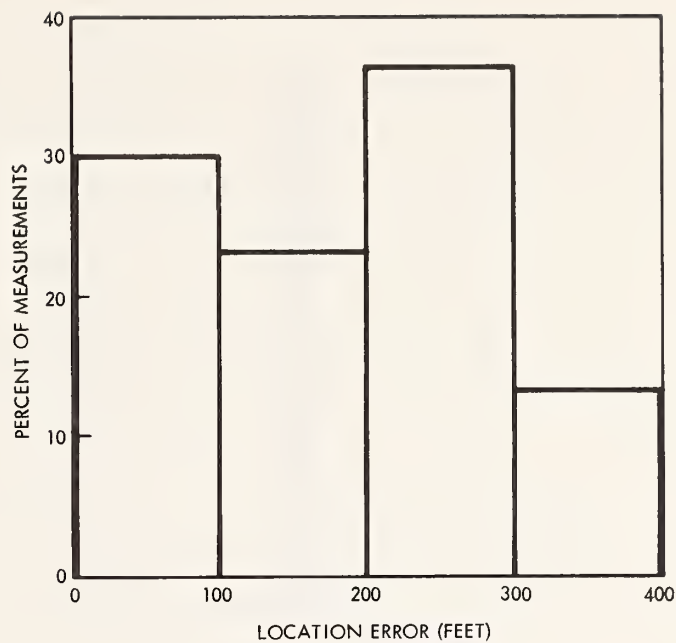
Figure 6-24A. LORAN Only Test - Location Accuracy Histogram
(32 Second Fixed Polling)

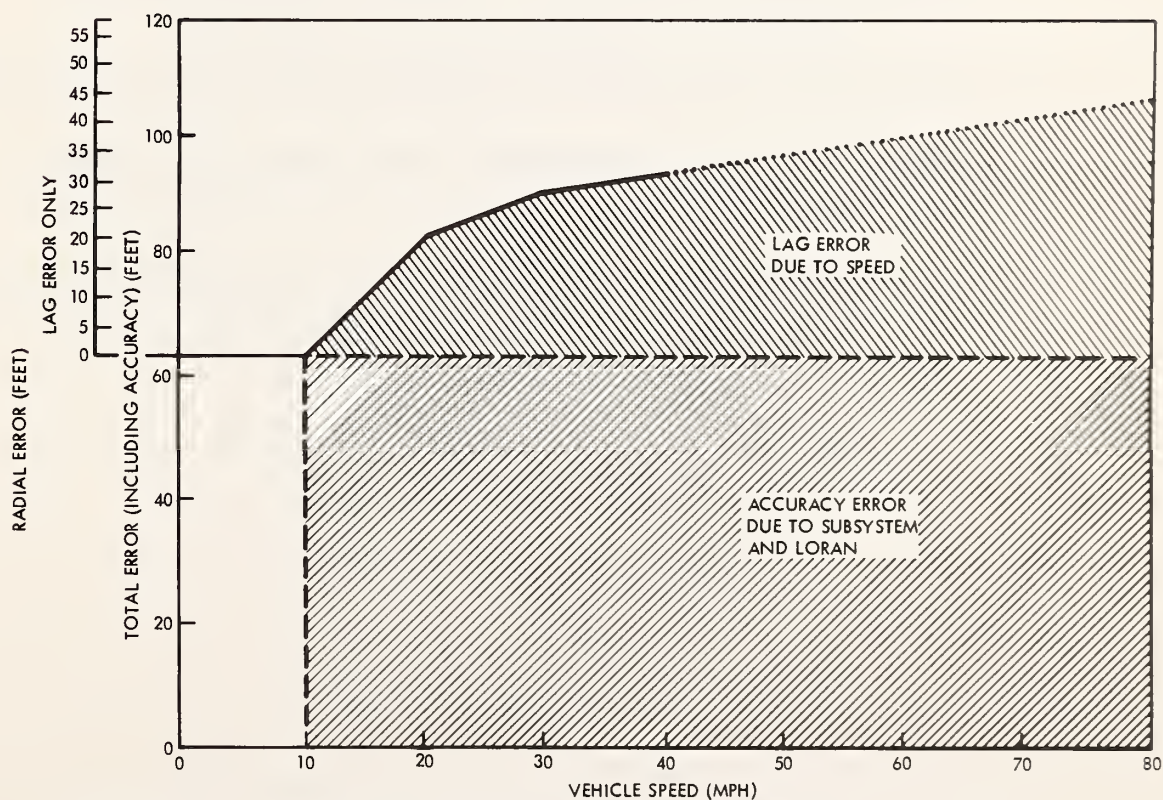
Figure 6-26. LORAN Speed/Lag Tests - Radial Error vs Speed

6.4.1.2 LORAN Speed/Lag Test - The results of the LORAN Speed Tests are given in Tables 6-6 through 6-15 and Figure 6-26. Figure 6-25 depicts the path and important measurements for the interpretation of the data. Calibration information was taken just as for the random and fixed routes. The results of the calibration are shown in Table 6-6. The gradient along the path used was .00186 microsecond/foot for time difference "A" and .00107 microsecond/foot for time difference "B." The Root Sum Square (RSS) standard deviation for TDA and TDB calibration was 69.4 feet. Tables 6-8 through 6-15 show the results of the speed tests in terms of radial, TDA, and TDB errors in feet for 10, 20, 30 and 40 MPH, respectively.

SPEED (MPH)	RSS ERROR (FT)		TDA ERROR (FT)		TDB ERROR (FT)	
		AVG		AVG		AVG
10	64	} <u>62.5</u>	32	} <u>33.5</u>	56	} <u>53.0</u>
	61		35		50	
20	90	} <u>83.0</u>	41	} <u>34.0</u>	80	} <u>75.5</u>
	76		27		71	
30	78	} <u>90.0</u>	42	} <u>45.0</u>	93	} <u>77.5</u>
	102		48		62	
40	82	} <u>93.0</u>	48	} <u>64.5</u>	66	} <u>66.0</u>
	104		81		66

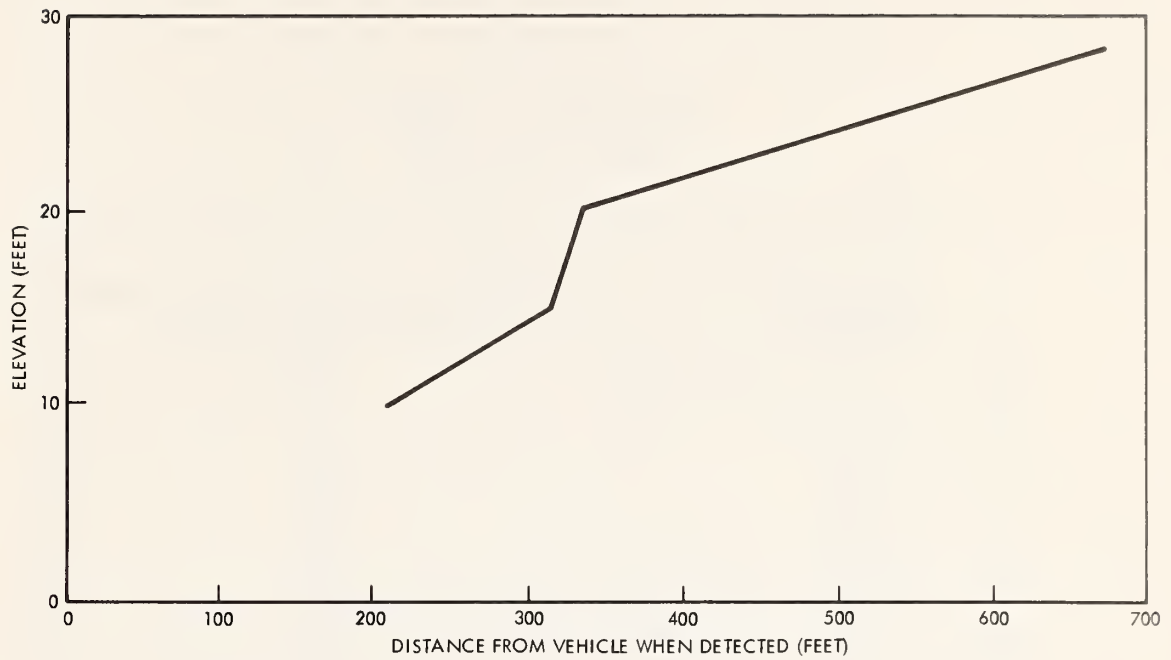
Figure 6-31A. Augmentor Detection Distance (In Traffic) Vs. Elevation

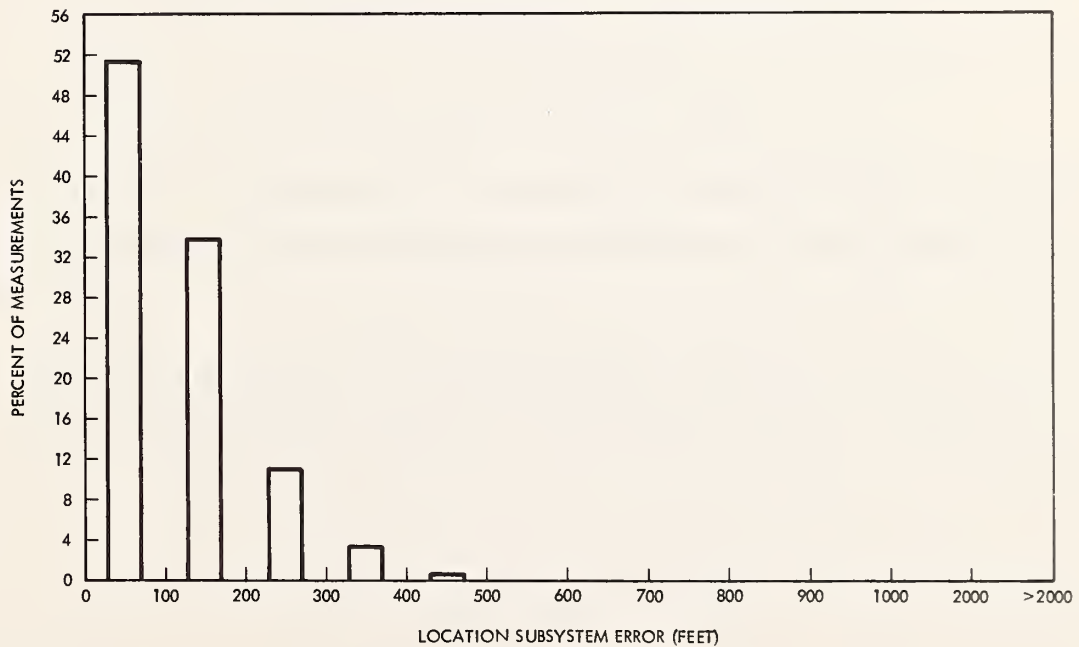
Figure 6-36. Location Subsystem Nighttime Accuracy
(Fixed Route Tests #10026 - 10047)

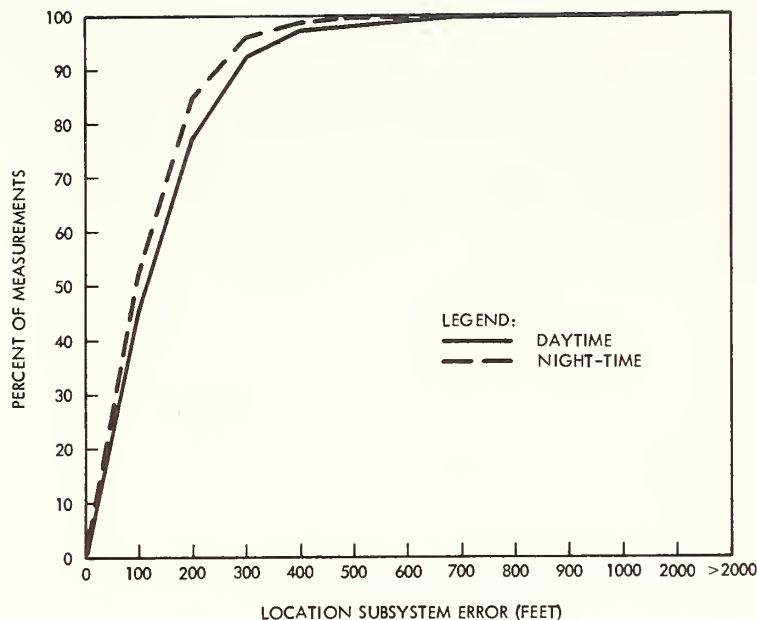
Figure 6-37. Fixed Route Cumulative Error By Time of Day

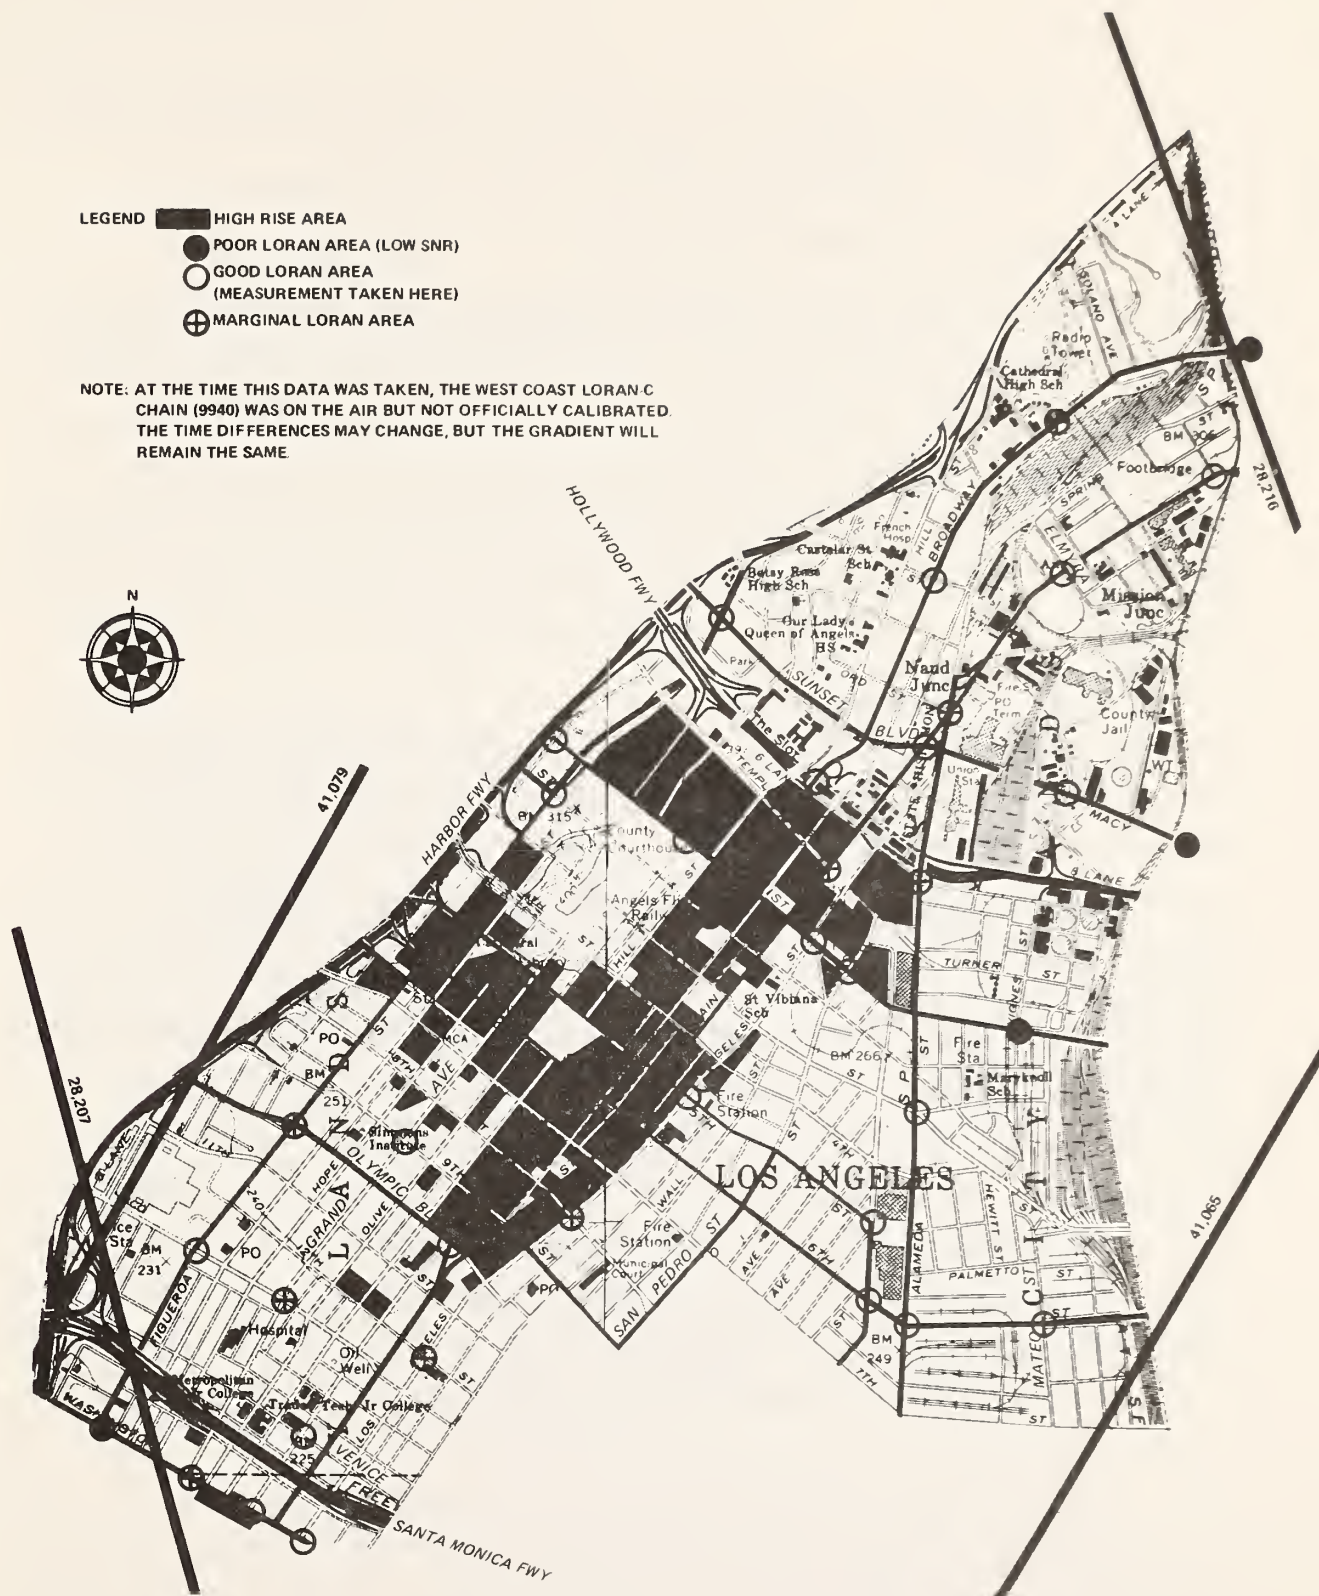
Figure 7-1. LORAN Coverage in the Phase II Random Route Area

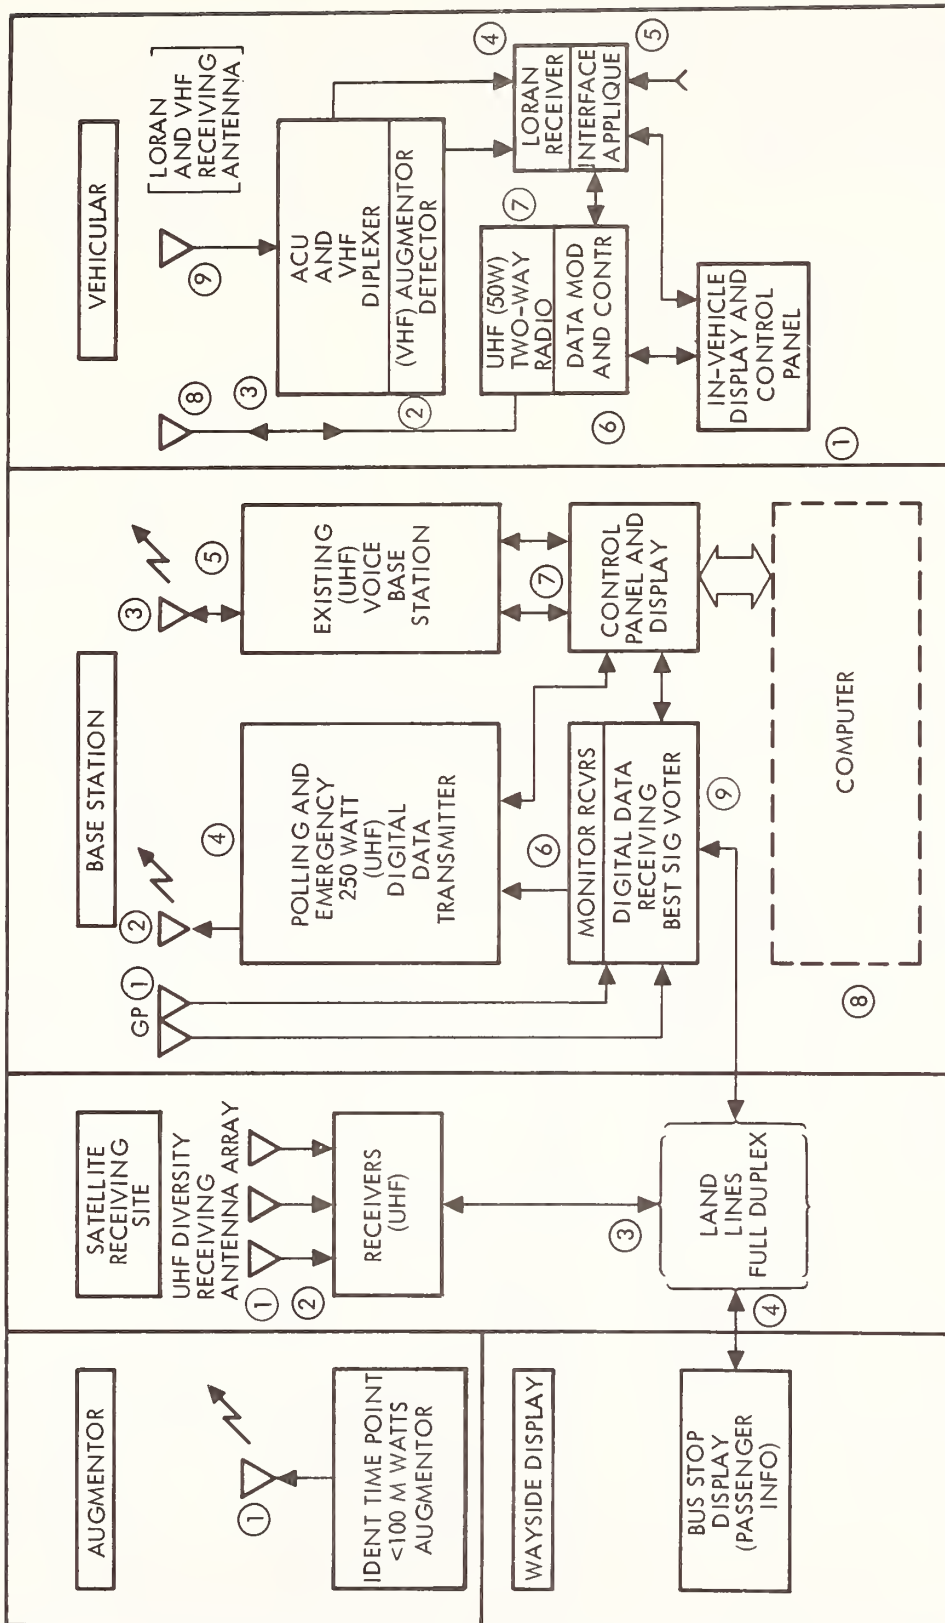
Figure 1-9. LAVM System Block Diagram
